# Coal Combustion Waste Impoundment Dam Assessment Report

## *Site 25*

### *Fly Ash Pond & Bottom Ash Pond American Electric Power Philip Sporn Generating Plant New Haven, West Virginia*

#### **Project # 0-381**

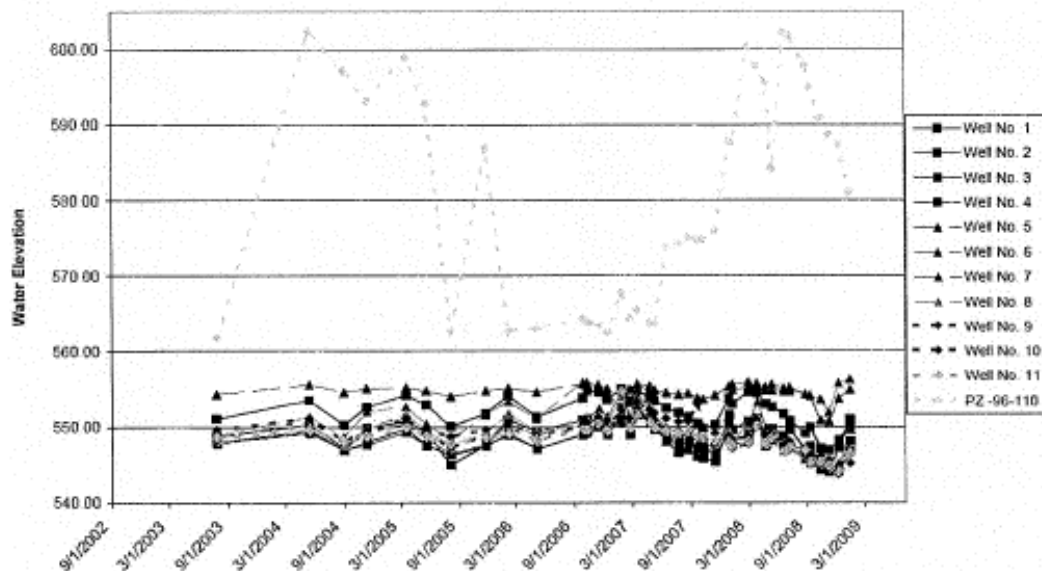
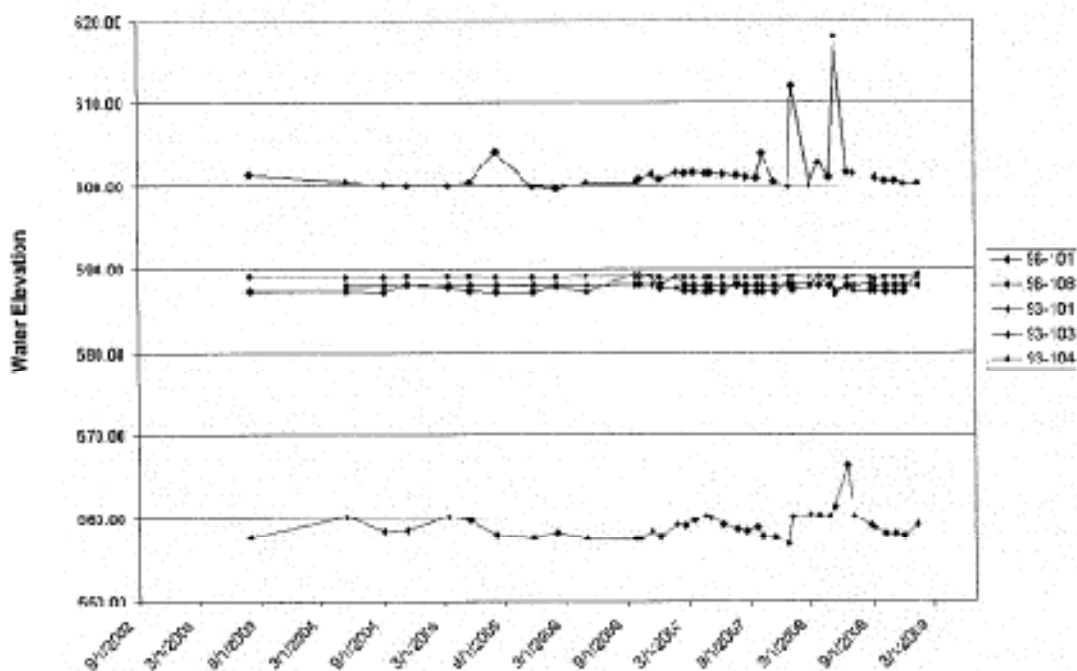
Sporn Plant Historical Well Readings

*Piezometer and monitoring well data are shown in the following graphs. It was noted in the previous report that the water level in Piezometer PZ 96-110 had risen back to levels similar to 2004 and 2005. The most current readings include five more data points than noted in the previous report, and indicate that the levels are dropping. In fact, the last 7 readings have steadily dropped since an elevation of 602.30' was recorded on 6-18-08. Overall, the most current reading of 581.10' represents the lowest reading since an elevation of 575.94' was recorded on 11-14-07.*
